**USAAVLABS TECHNICAL REPORT 70-66**

MODE OF FAILURE INVESTIGATIONS
OF HELICOPTER TRANSMISSIONS

CONTRACT DAAJ02-69-C-0061
BELL HELICOPTER COMPANY
FORT WORTH, TEXAS

This report presents the results of a program of review and analysis of failed parts rejected during UH-1 and CH-47 transmission overhaul at ARADMAC. The program was conducted to identify the modes of failure and to reveal areas requiring additional research or development to improve engineering design capability.

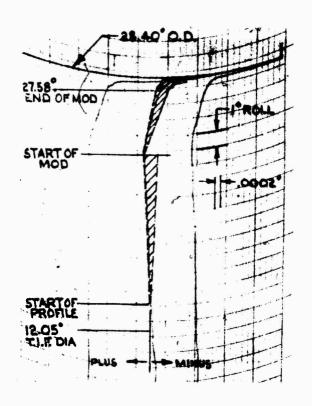
Items No. 1, 2, 37, and 38 - Tail rotor drive train gears (P/N)'s 204-040-103-7, 204-040-104-13, 204-040-762-1, and 204-040-763-1). The maximum replacement rate for these four gears was 5.8%, which was exhibited by the 204-040-104-13 spiral bevel pinion (driven member). There were no primary failures in this group, and all except one pair of bevel gears (Items 1 and 2, P/N's 204-040-103-7 and 204-040-104-13) could have continued in operation. This set of gears was scored and spalled on the face of the teeth (Figure 15) as the result of running without oil. Examination of the microstructure disclosed rehardening at the surface in the scored area. Operation without oil was evident in this component at disassembly on the main input bevel gears as well as on this set. Items No. 37 and 38 spur gears were replaced because of scuffing at the tip of the pinion teeth (Figure 16) and in the flank of the gear teeth, and for corrosion damage. Scuffing to a lesser degree is not uncommon on this set and is somewhat selfcorrecting. Current overhaul documents permit this condition provided the maximum depth of material removed does not exceed 0.0004 inch. In normal overhaul procedure this condition is evaluated visually without setting up the gears in an involute test machine, since ARADMAC does not have gear inspection equipment. Involute traces run (at BHC) on the most severe sample parts show that the maximum depth of wear rarely exceeds this limit (Figure 17).

Figure 17. Involute Profile Trace of Tail Rotor Driven Pinion (P/N 204-040-762-1).

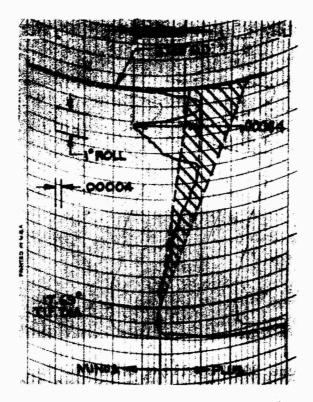
Figure 28. Involute Trace of Lower Sun Gear (P/N 204-040-329-1).

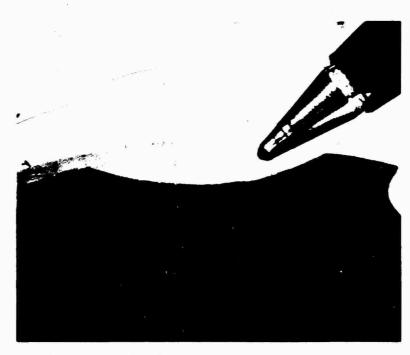
Figure 41. Pitted Inner Surface of Oil Pump Gerotor (P/N GC1669).

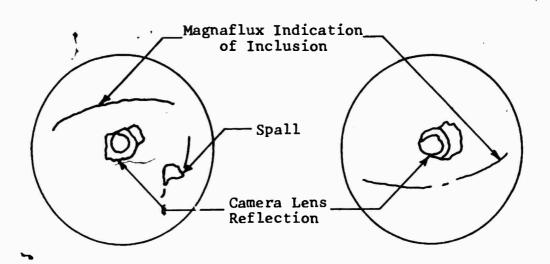
(C) Identification Sketches of Above Photographs

Figure 44. Nonmetallic Inclusions in Bearing Balls.

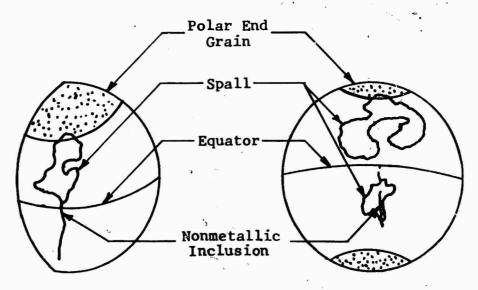
(A) Photographs of Deep Etched Bearing Balls at 1.5X

Figure 45. Deep Etching of Bearing Balls.

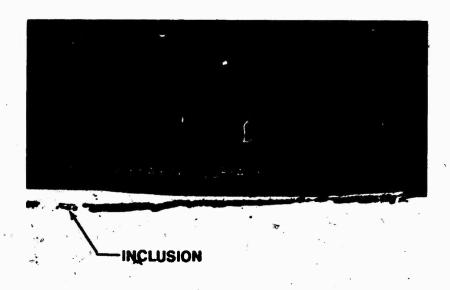
Item No. 4A - Bearing, lower planetary (P/N 114DS244-12), had one primary failure. An additional 40 parts were replaced because of limited life. All except one of these were adjudged to be serviceable. The failed bearing had an incipient spall in the inner race (Figure 54). No metal had yet been lost from the spalled area, and the failure appeared as a crack. Magnetic particle inspection of the ring revealed no indications other than those visible to the naked eye. The ring was inspected after surface temper etch, a technique used to reveal localized hard or soft areas resulting from overheating (usually due to grinding) or work hardening. There were very faint lines oriented circumferentially around the race that may have been caused by grinding damage, or they may be the result of bearing operation. Hardness, Shepherd Fracture grain size, and retained austenite were all satisfactory. Microstructure was good and the steel was very clean. micro-nonmetallic inclusion content of a cross section through the failure is shown in Table VI and indicates that the steel is probably vacuum melted. A metallographic examination of the surface through the failed area revealed a crack that appeared to start at the surface (Figure 55) and propagate almost parallel to the surface, remaining very shallow. suggests a point surface origin, often associated with insufficient lubricant film thickness for the relative roughness of the contacting parts. There is an inclusion in the failed area with the crack extending out in both directions, but as may be seen in Figure 56, the crack does not extend through the inclusion.

Figure 55. Section Through Crack in Bearing Race (P/N 114DS244-13) (Magnification 100X).

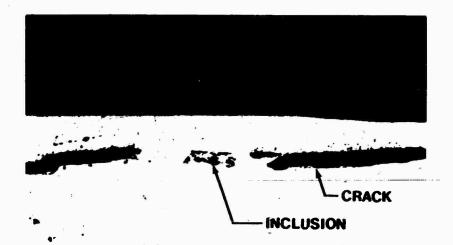
Figure 56. Enlarged Section Through Crack in Bearing Inner Ring (P/N 114DS244-13) (Magnification 200X).

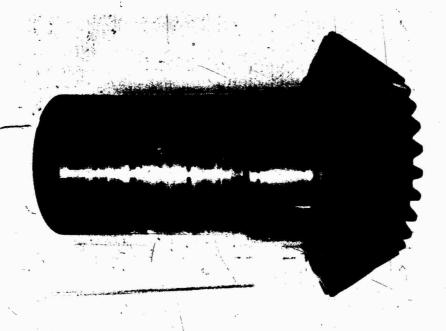
Figure 66. Wear on Bearing Journal of Input Pinion (P/N 114D2O45-5).

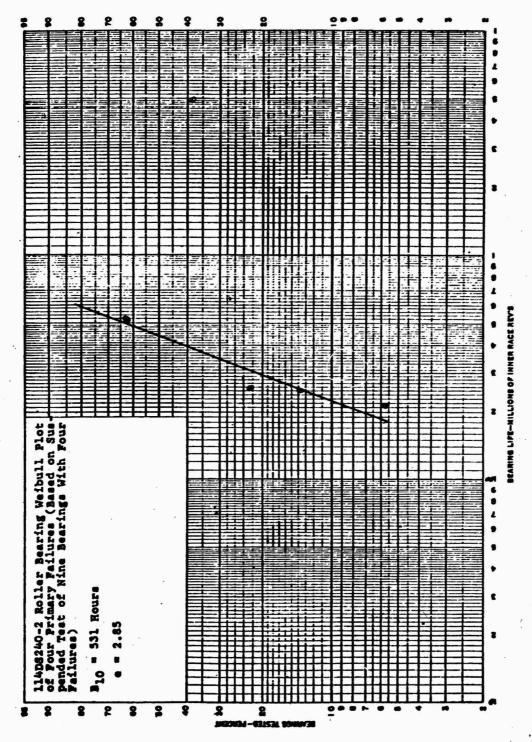
The predicted service B10 life from Figure 100 is approximately 109 inner ring revolutions. The calculated B10 at 100% power is 17.5 x 106 revolutions. Applying the often used life improvement factor for M-50 material (5) gives 87.5 x 106, close to 108 revolutions. If a cubic or quartic mean spectrum sufficient to obtain an equivalent life increase of 10 were employed, an average power setting requirement of 50% takeoff would result. This appears a bit low. One is left to conclude that in this instance the experienced life exceeds the accepted calculated life.

Figure 100. Failure Distribution of 114DS240 Bearing by Suspended Test Analysis.

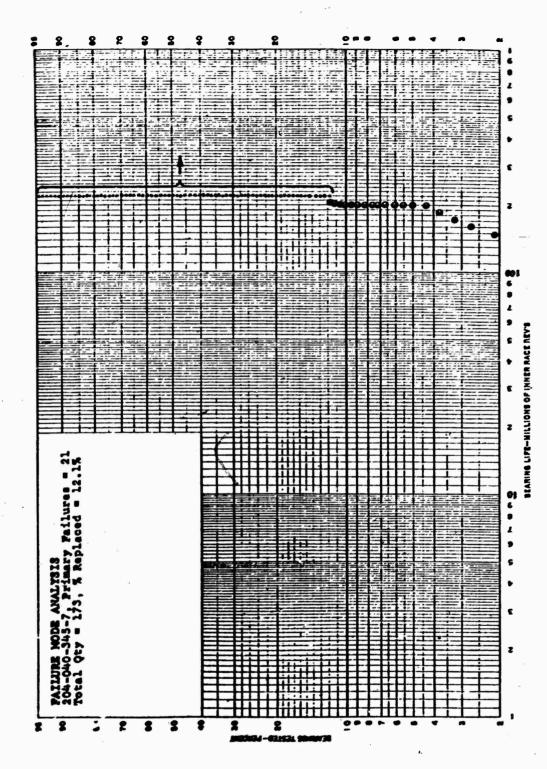
In the instance of Figure 101, the predicted service  $B_{10}$  life is approximately 2.5 x  $10^8$  inner ring revolutions. The calculated  $B_{10}$  is 1.15 x  $10^8$  at 100% power. Using a life factor of 2 for clean vacuum degassed 52100 gives a corrected  $B_{10}$  of 2.3 x  $10^8$ . This value is essentially identical to that experienced. However, it is doubtful that the UH-1 is operated at 100% power for 100% of the time. A reasonable cubic mean level would be 70% power. The calculated correction would be  $(\frac{1}{3})^3 = 2.74$  for a new  $B_{10}$  of 6.2 x  $10^8$  revolutions.

Figure 101. Failure Distribution of 204-040-345 Bearing.

In this instance the experienced life is less than that calculated. In general, these results add to our earlier findings concerning the disparity in roller over ball bearing calculated experienced life ratios.
